Borrego Springs Field Test Summary

Clarum Homes

Borrego Springs, CA

Test Dates: May 16-21, August 2-9, 2006

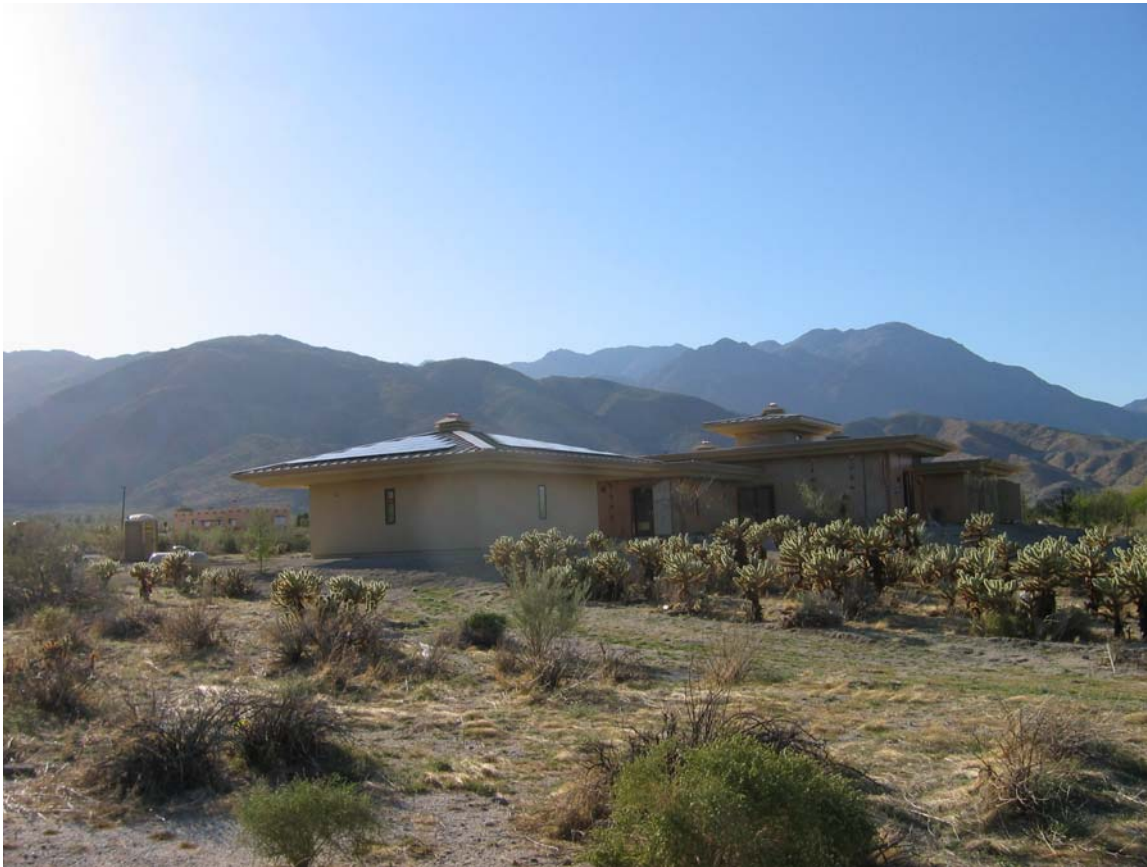
Figure 1 Wagon Prototype, Completed

Walls of this house are constructed using the Dow “T-Mass” product, a pre-cast concrete -foam-concrete sandwich. A radiant floor system using DEG’s “Rapid-Radiant” system, which includes

tubing preattached to concrete reinforcing mesh, will provide heating. The heat source is a plate heat exchanger connected to a tankless water heater. The tankless water heater also provides domestic hot water on a priority basis. Cooling is supplied by two systems. An OASys two-stage advanced evaporative cooler will operate during the dry season to provide efficient (~EER 40) cooling. During the monsoon season the owners can switch to a vapor compression system which chills water that flows first through a fan coil to provide dehumidification, and then through the same floor tubing that is used for heating. This design eliminates most of the ducting since the OASys supplies cooled outside air from a single point that flows out of the house through barometric dampers, and the radiant floor system provides distribution during the monsoon season. Ducting for the chilled water fan coil is limited to the kitchen and living area, and is in conditioned space. Figure 1 shows the Wagon home as built.

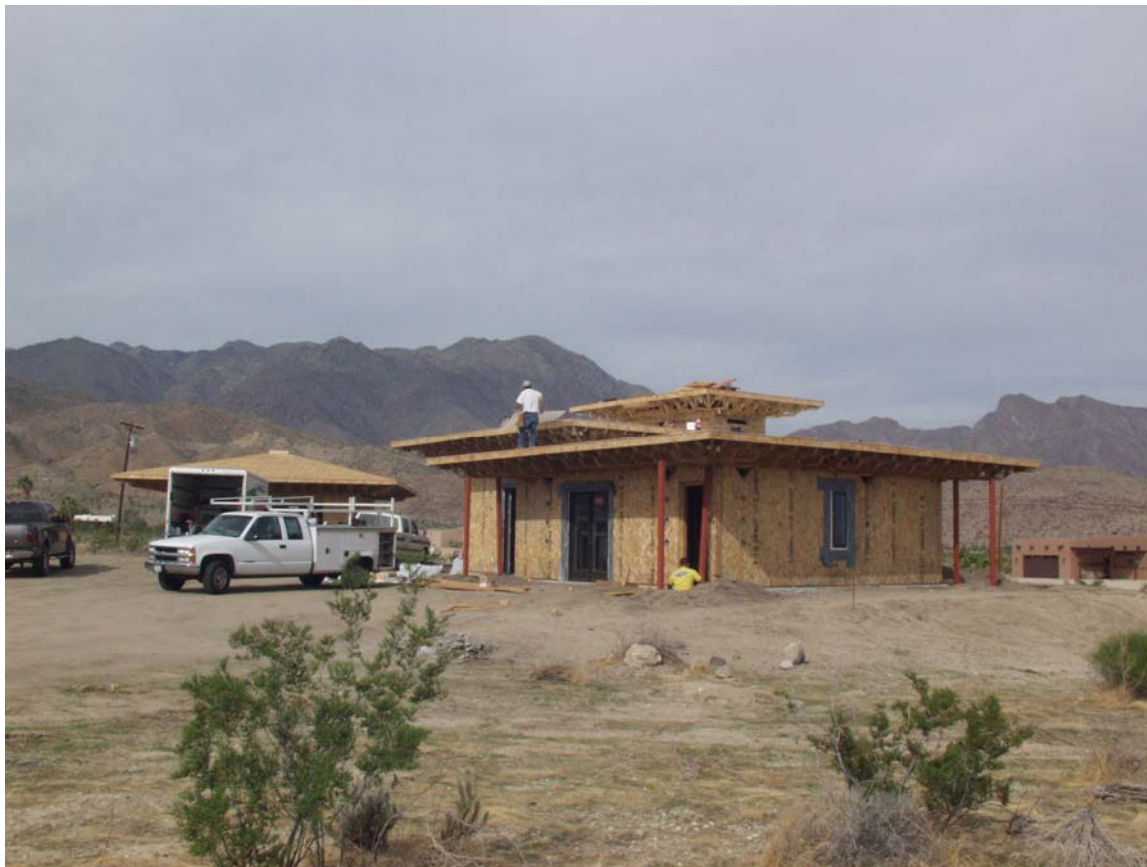
Figure 3 Broken Arrow Prototype Under Construction

The Broken Arrow house is constructed using SIP panels for exterior walls. It will employ a similar system as used for the Wagon house including radiant heating and evaporative cooling using the OASys system. However, cooling (and dehumidification) during monsoon conditions will be provided from a conventional ducted forced air system, with ducts in conditioned space. The floor will not be used for cooling. Figure 3 shows the Broken Arrow home during the construction phase.

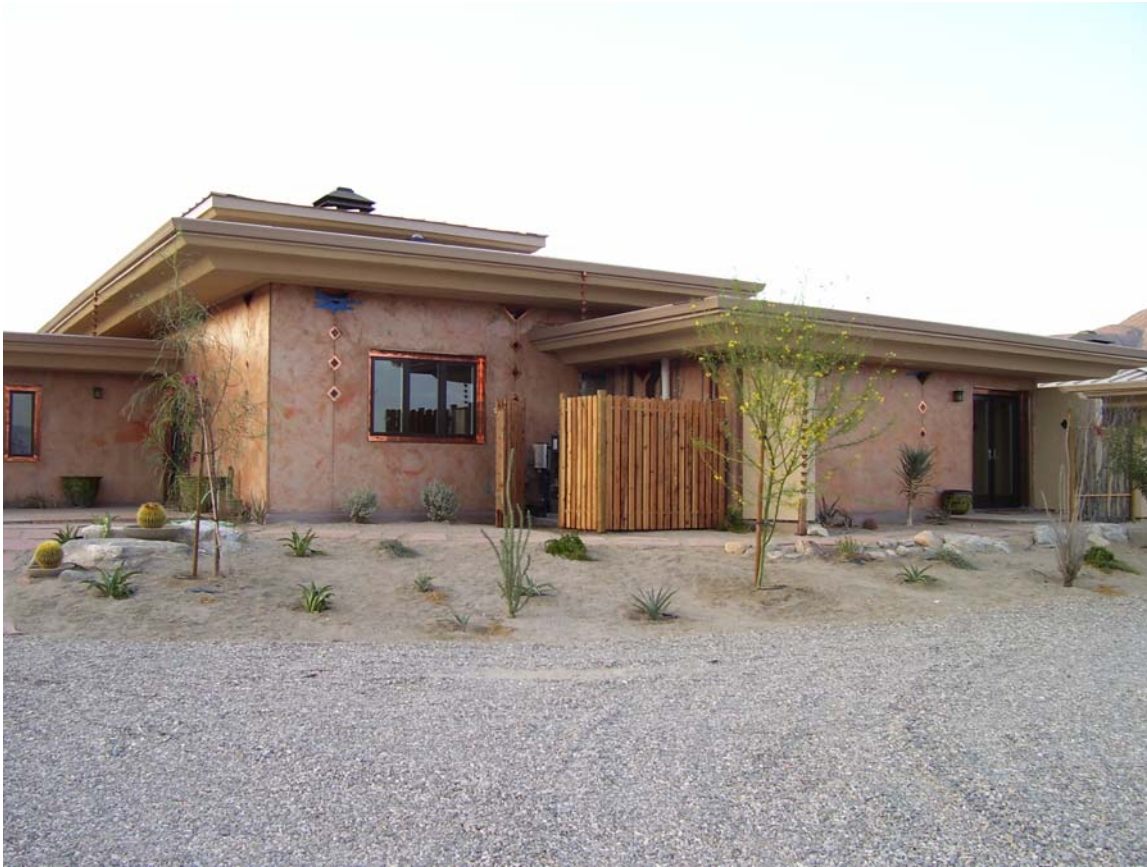
Figure 5 DiGiorgio Home, Completed

The DiGiorgio house will use the same T-Mass wall system as the Wagon house. This house will include a fully ducted (inside conditioned space) heating and cooling system that uses a NightBreeze integrated system to provide combined hydronic heating, forced air cooling, ventilation cooling, and fresh air ventilation. The tankless water heater will be used as a heat source, and a Freus evaporative condenser will provide cooling via a direct expansion evaporator coil. To reduce cooling loads, the Freus fan and pump will be operated at night during summer and transition seasons to produce cool water that will be piped through coils in the slab floor. This use of the Freus as a cooling tower will be disabled whenever vapor

compression cooling is needed. The floor tubing will not be used for heating. Figure 5 shows the DiGiorgio home as built.

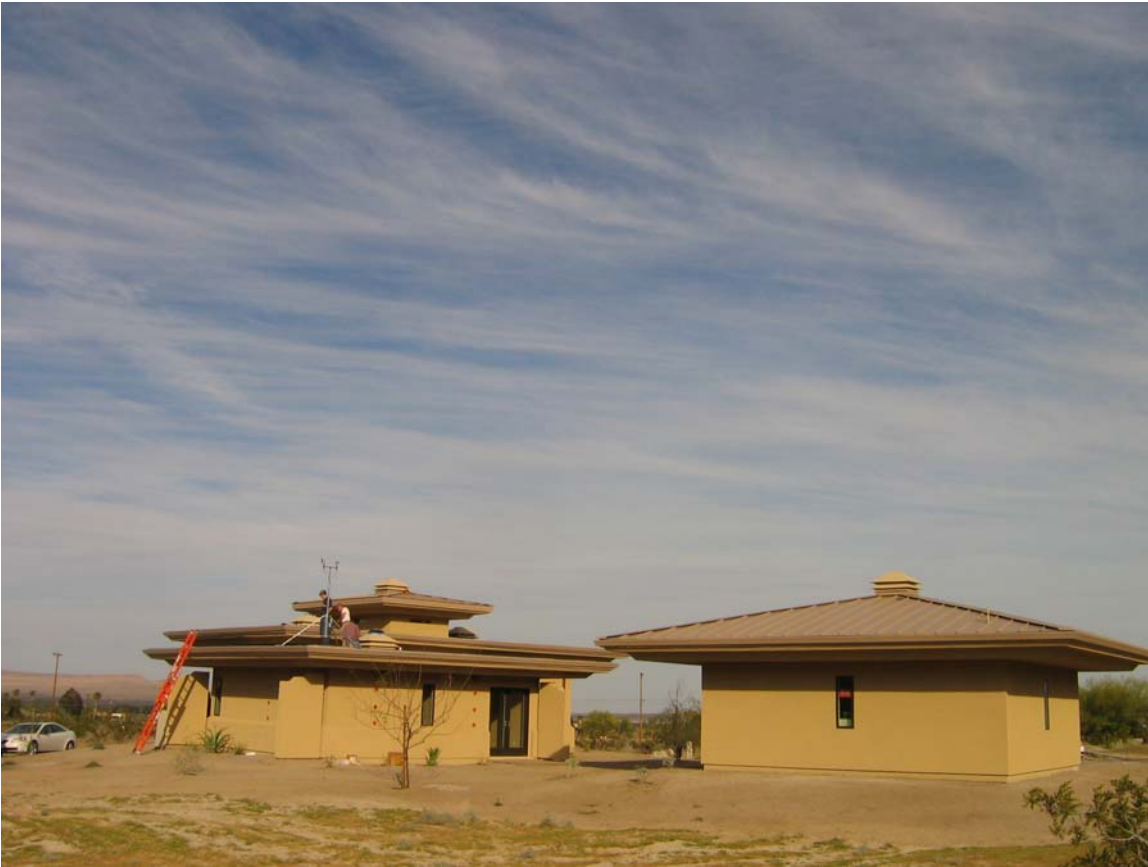
Figure 7 East Star Prototype Completed

conditioned space. No evaporative cooling will be employed at this house. Figure 7 shows the East Star home as built.

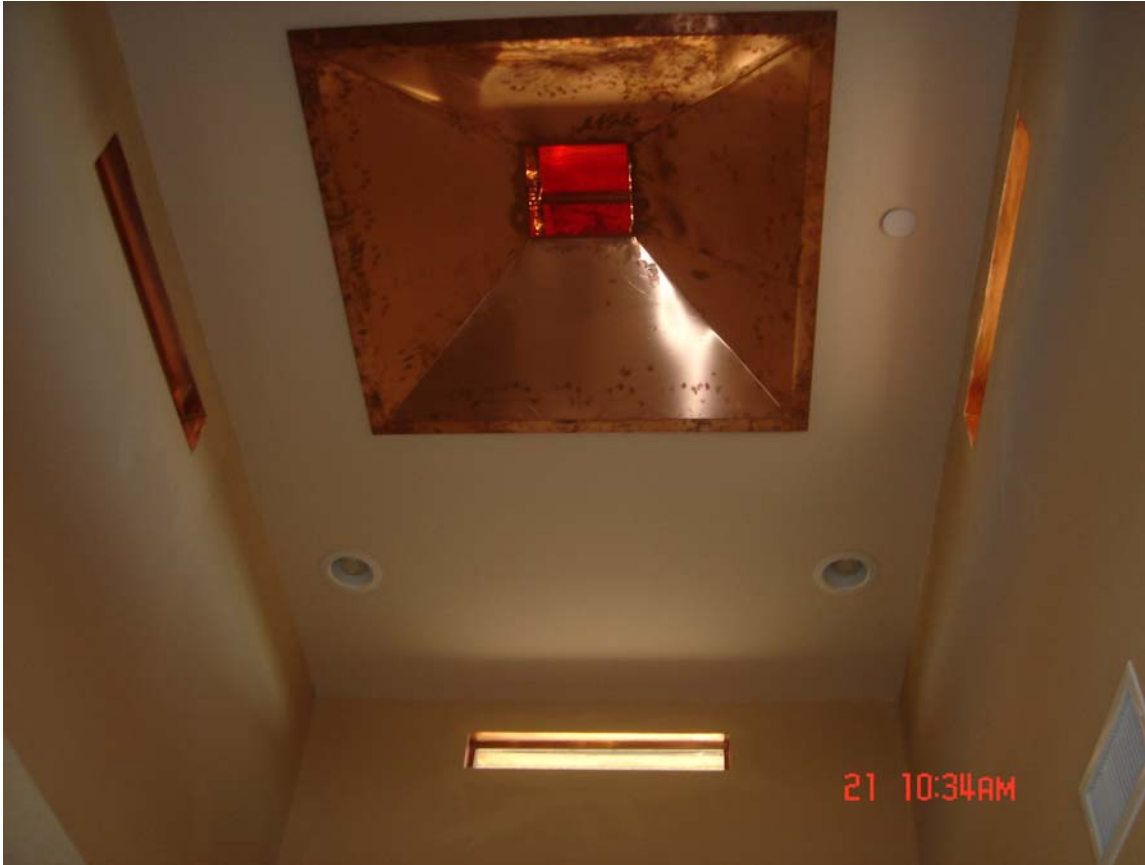
Figure 9 Copper Flashed Skylight Typical of Borrego Prototypes

These homes had a number of custom skylight and window features which were found to be very leaky even after additional caulking was performed to seal the custom copper skylight and window flashing (pictured in figure 9)

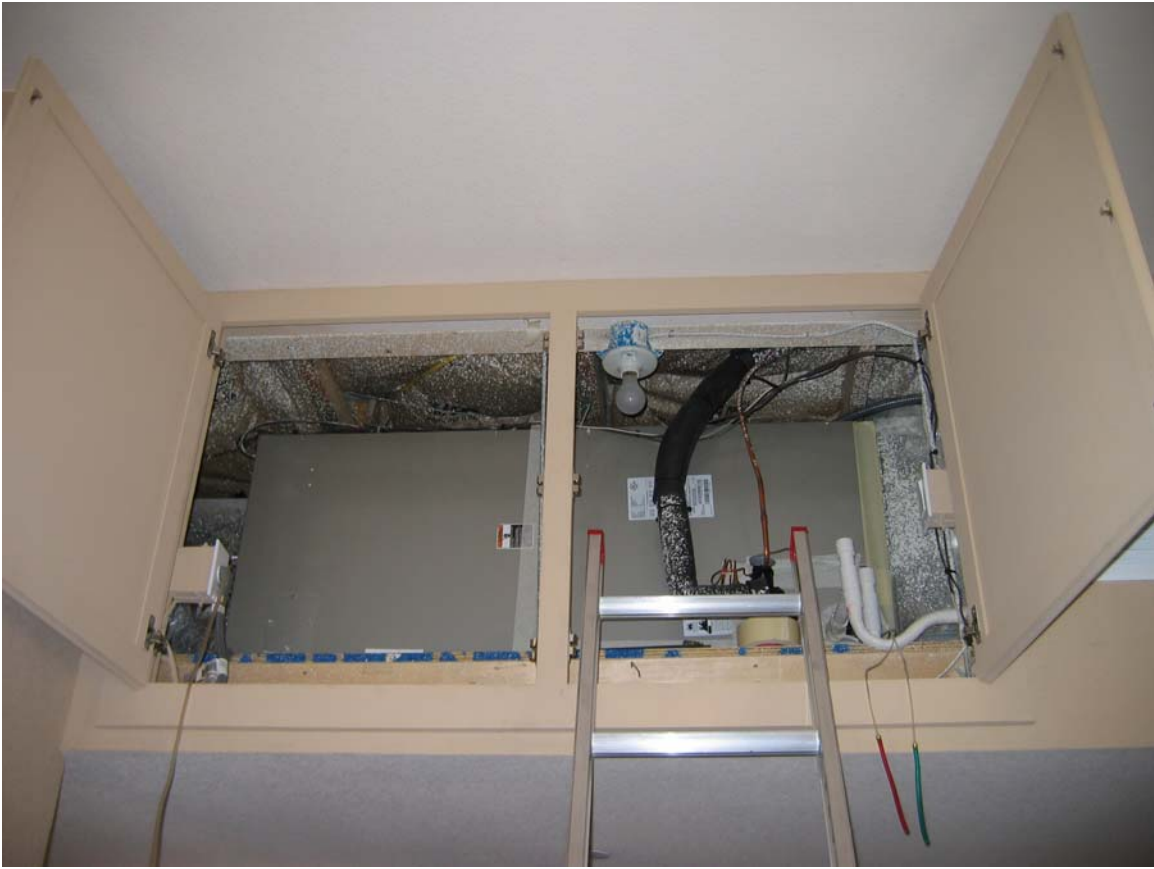
Figure 10 Air Handler Attic Access Cabinet Typical of Borrego Prototypes

The performance of the homes also suffered due to an air handler location that used these cabinet doors above the kitchen as the “air barrier” between the conditioned space and the attic where the air handler was located in each home with the exception of the Wagon home. Figure 10 shows the typical placement of the air handler in the attic for the Borrego prototypes.

This poor placement and air sealing method was not the original design intent but rather how the builder implemented the HVAC installation. Several attempts were made to improve the separation of the air handler space from the rest of the attic in an effort to reduce air leakage, however, the low pitch roof and shallow attic space made completely sealing off the air handler cabinet from the rest of the attic space impossible. Table 6 shows the infiltration estimate for the homes at Borrego Springs after the builder performed additional air sealing on each home.

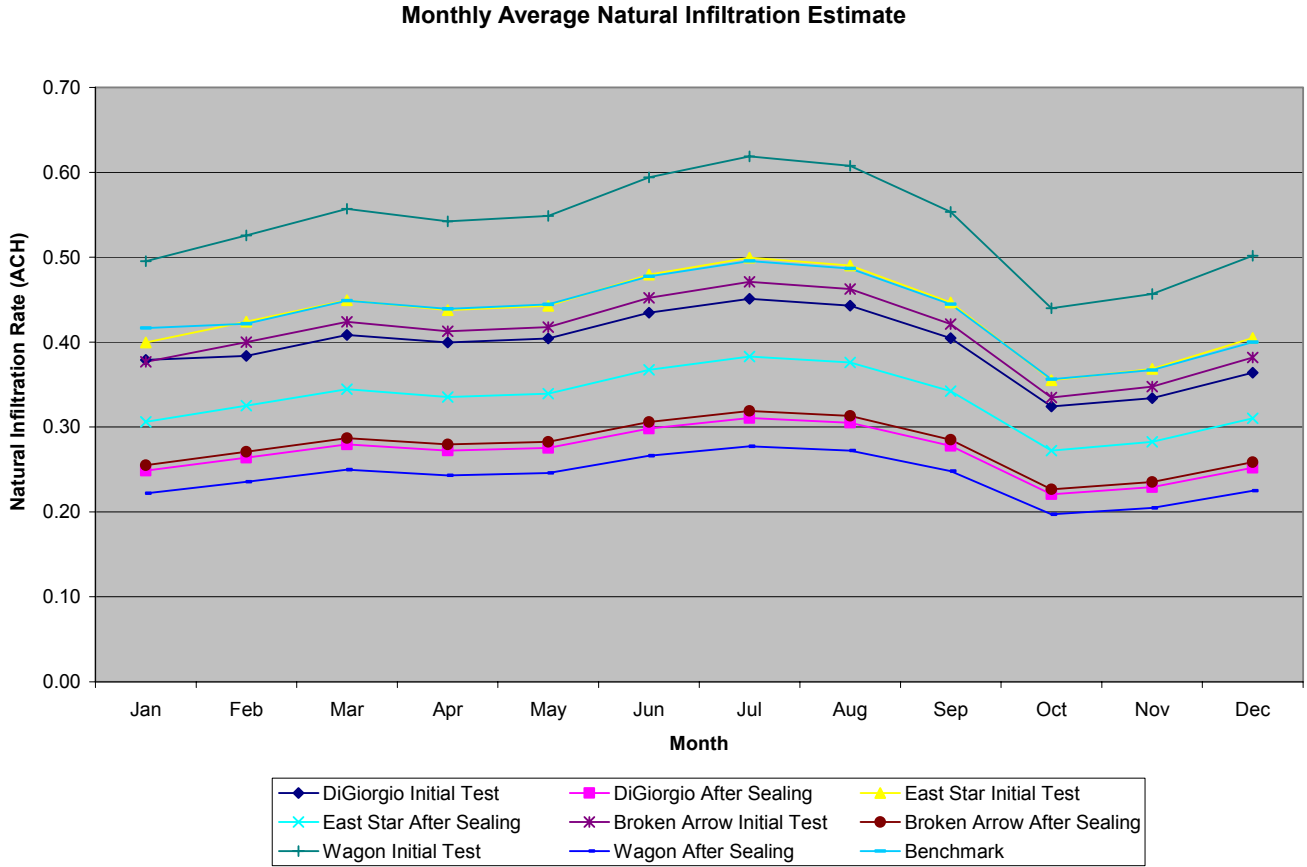
Figure 11 Natural Infiltration Estimate Plot for Borrego Springs Homes before and after Additional Air Sealing.

Figure 11 plots the estimated average infiltration rates for each home before and after the builder performed additional air sealing.

Sealing efforts made by the builder did make a difference in the air tightness of the homes. Table 7 shows the estimated leakage area (ELA) for each home before and after sealing and the percent reduction in ELA.

Figures 12 & 13 support the blower door based infiltration estimates shown in Figure 11, indicating that the initial infiltration performance of the homes was much worse than expected. CONSOL staff communicated the air leakage testing results to the builder and the builder responded by implementing additional sealing measures on each of the homes. In August of 2006 NREL staff returned to Borrego Springs for another round of testing, repair and installation of instrumentation. Additional air sealing of the homes had been completed. Blower door testing shows that additional air sealing had improved the infiltration performance of the homes, however, the prototypes at Borrego have noticeably reduced infiltration performance compared to other current prototype homes in the Building America program. Figure 14 shows the infiltration performance for the East Star home after additional air sealing measures.

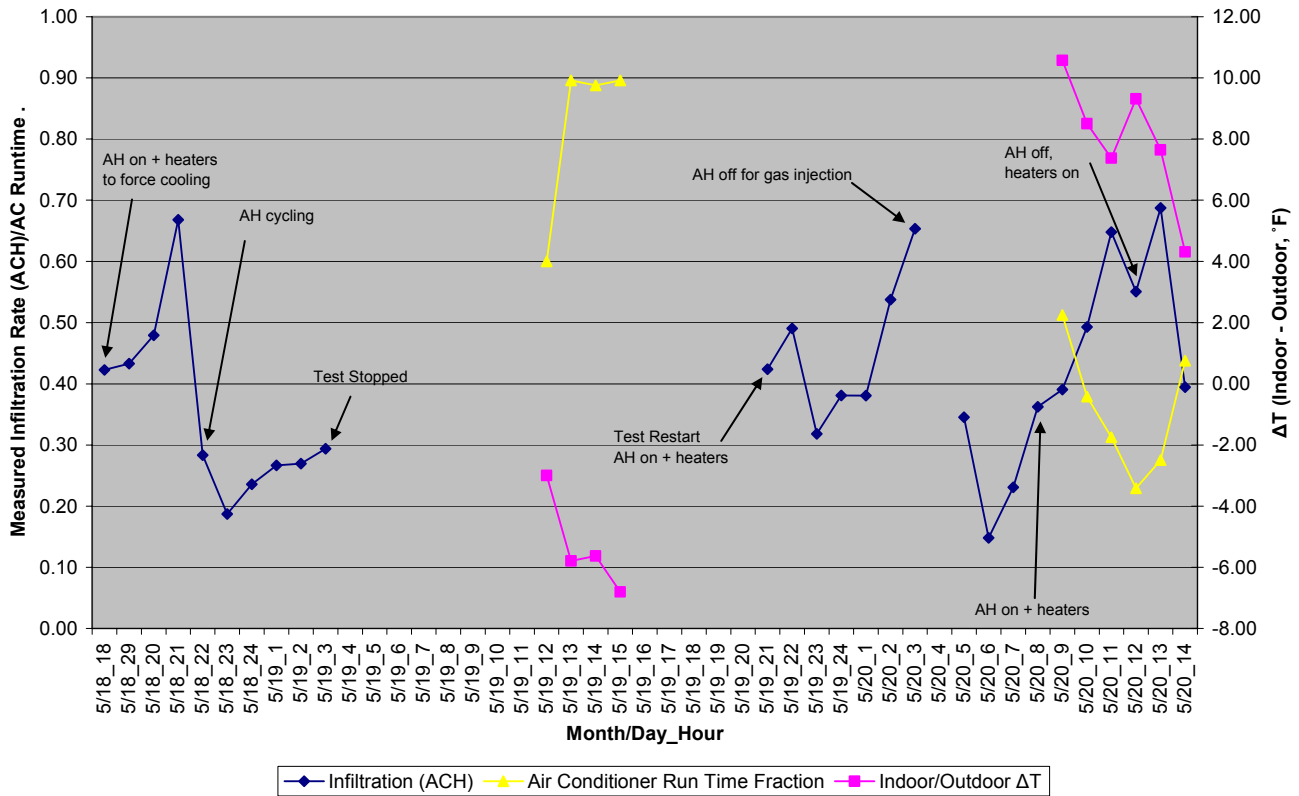
Figure 12 Tracer Gas Test Results for East Star, May 2006

During this test long term data acquisition for the East Star home was unreliable, as a result limited data for air conditioner runtime fraction and indoor/outdoor temperature differential are available. To force air conditioner operation during this test NREL staff used several small electric heaters to place a cooling load on the home so that infiltration could be measured during air conditioner operation.

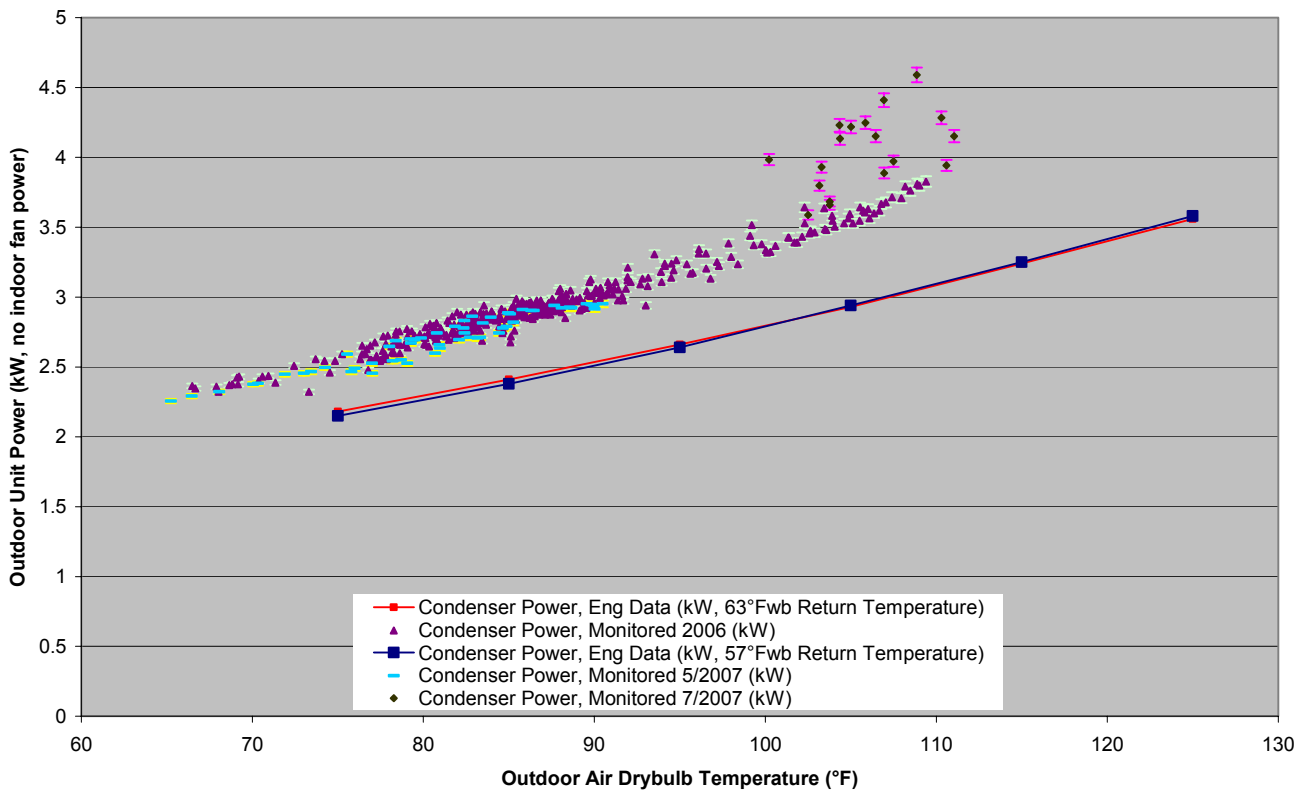
Figure 21 SEER 13 Outdoor Unit Power Comparison

The comparison to manufacturers power draw is presented for the condensing unit only as including the air handler in the comparison would complicate the comparison unnecessarily due to the difficulty in knowing the duct system static pressure when the system operates (currently there is no measurement of duct system static pressure).

Data for the SEER 13 air conditioner was only valid from August 2006 until the end of the 2006 cooling season due to a temperature and relative humidity sensor failure that was corrected during the August site visit, data from some of the warmer parts of the summer is not available. The comparison shows the measured power of the condensing unit to be higher than would be

expected from the manufacturer's data and may indicate incorrect refrigerant charge. Figure 22 shows the cooling capacity comparison for the SEER 13 air conditioner.

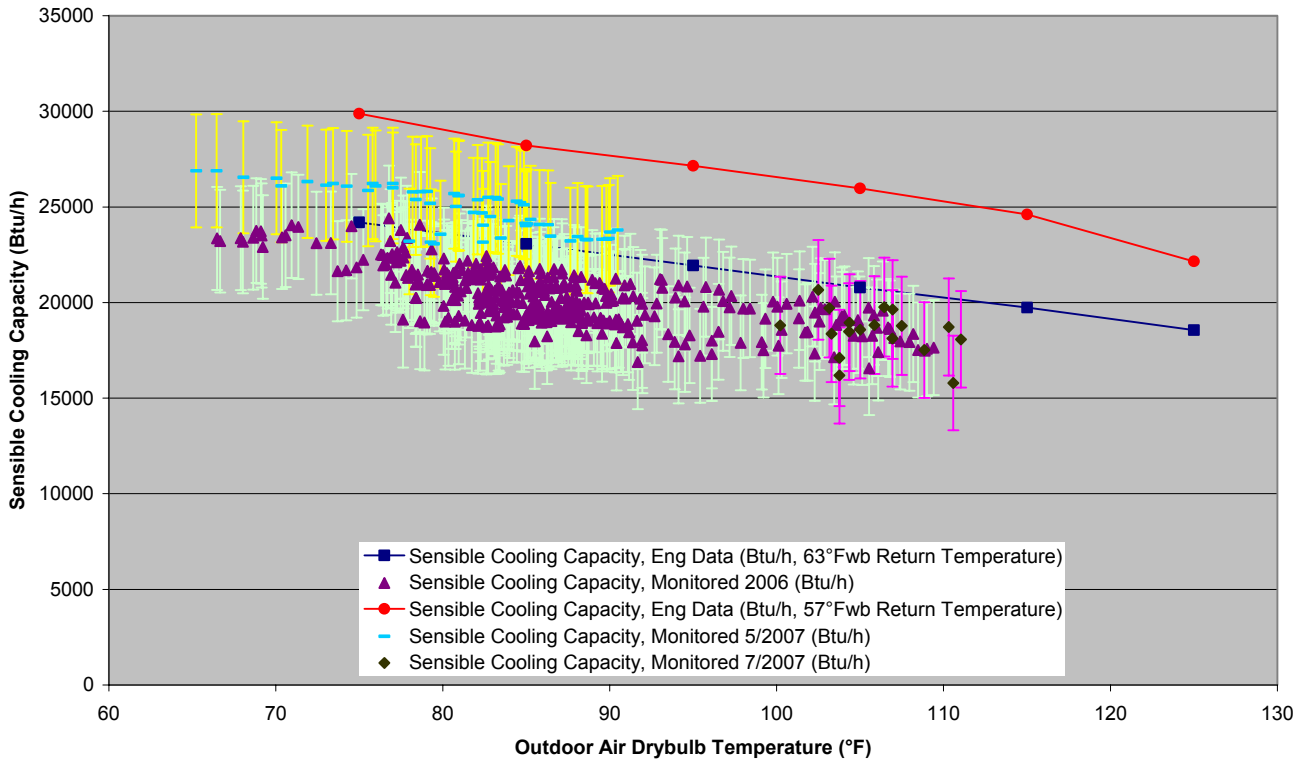
Figure 23 Sensible Cooling Capacity Comparison for SEER 13 Air Conditioner
 The measured sensible cooling capacity has less uncertainty associated with the measured values and still shows a reasonable comparison to the manufacturer's data. Figure 24 shows the EER comparison for the SEER 13 air conditioner.

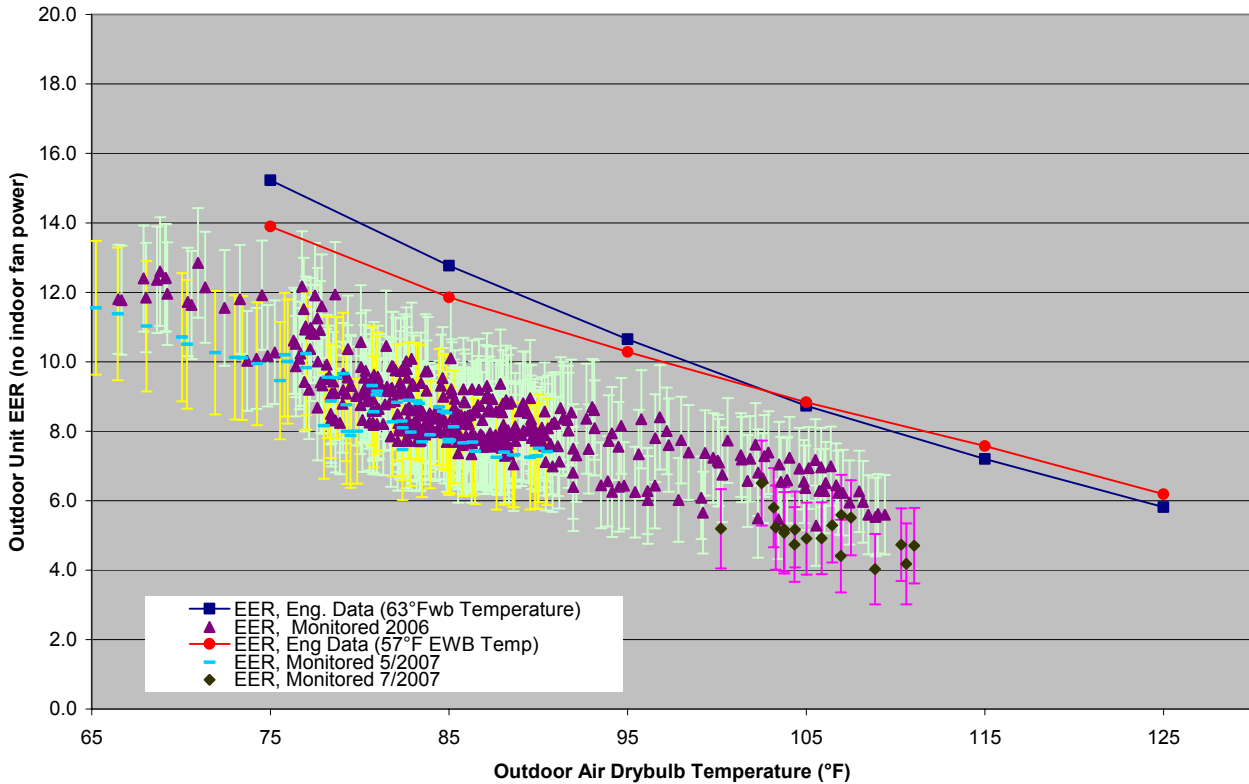
Figure 24 EER Comparison for SEER 13 Air Conditioner

Figure 24 shows the measured EER to be lower than the manufacturer's data would indicate. The reason for the higher than expected outdoor unit power has not been determined at this time but the manufacturer has become involved in analyzing the data and is aware of the discrepancy.

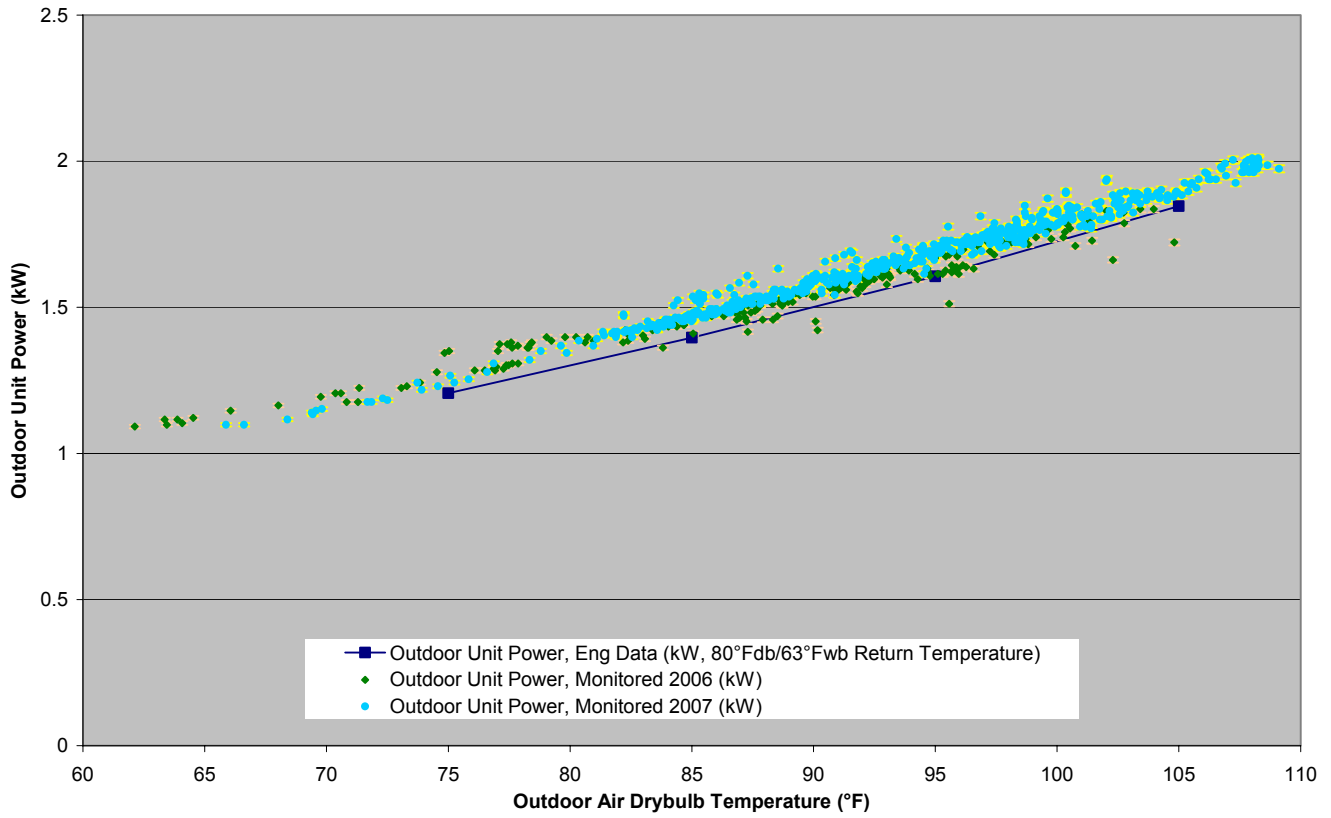
Figure 25 SEER 21 Power Comparison, 1st Stage Operation

The manufacturer's data agrees with the field monitored data for power draw, with the filed data only showing a very slight trend towards a higher power draw during 1st stage operation. Figure 26 shows the comparison of Manufacturer's total cooling capacity data compared to field monitored data for the SEER 21 air conditioner in 1st stage cooling at the East Star site.

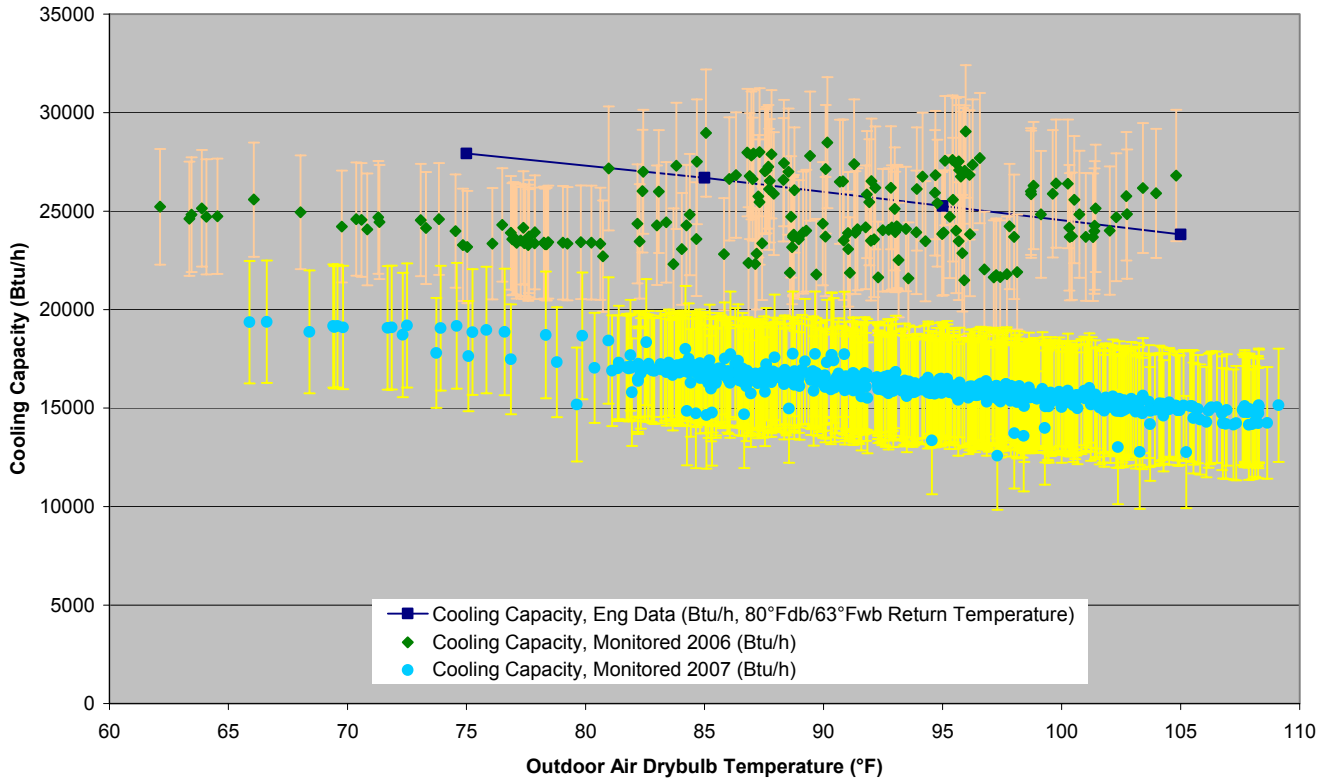
Figure 26 SEER 21 Total Cooling Capacity Comparison, 1st Stage Operation

The 2006 total cooling capacity data compared well with manufacturer’s data, however the supply and return duct temperature and relative humidity sensors were replaced at this location before the summer 2007 cooling season. NREL staff suspected that the sensors installed for the 2006 cooling season were giving false readings and replaced the sensors in January and May of 2007.

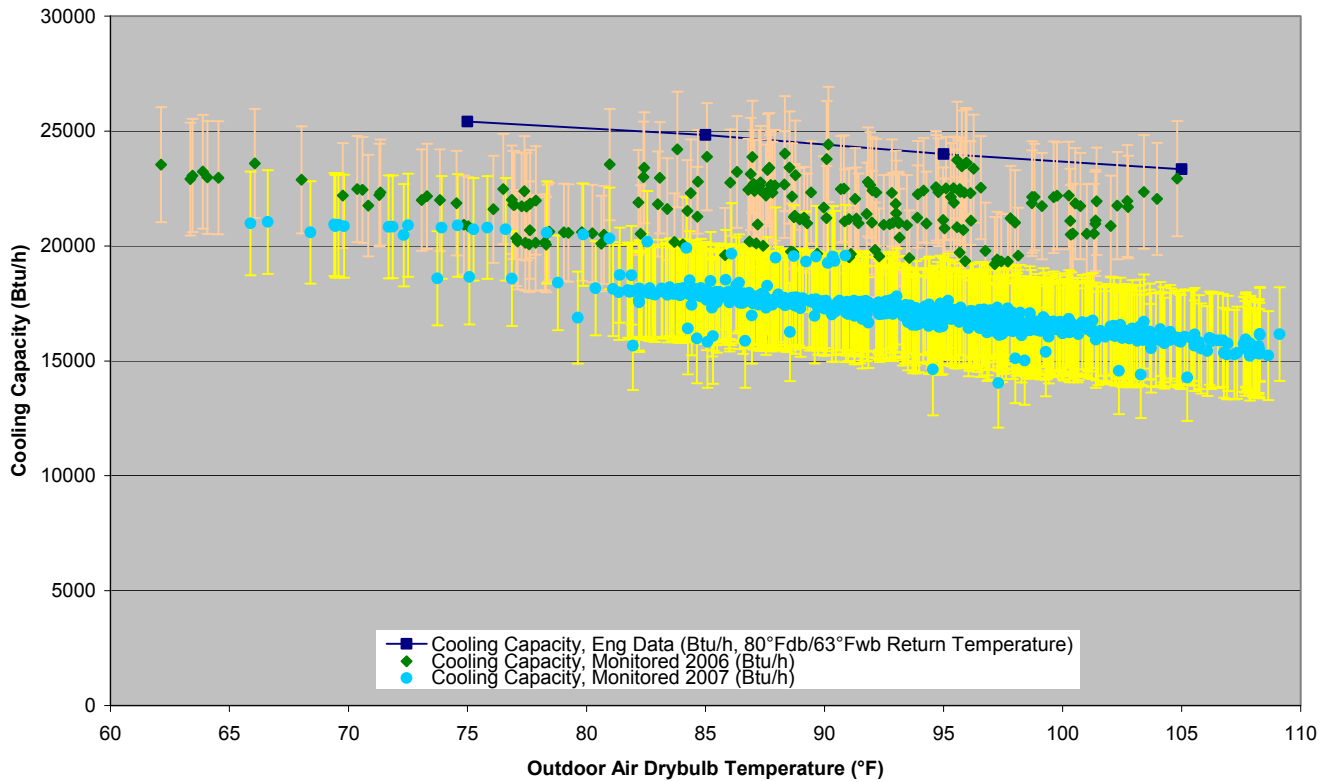
Figure 27 Sensible Cooling Capacity Comparison for SEER 13 Air Conditioner

Figure 27 shows the sensible cooling capacity comparison for the SEER 13 air conditioner.

Sensible cooling capacity for 1st stage operation shows a similar difference in performance of the unit from 2006 to 2007 that we currently believe to be sensor related as described above.

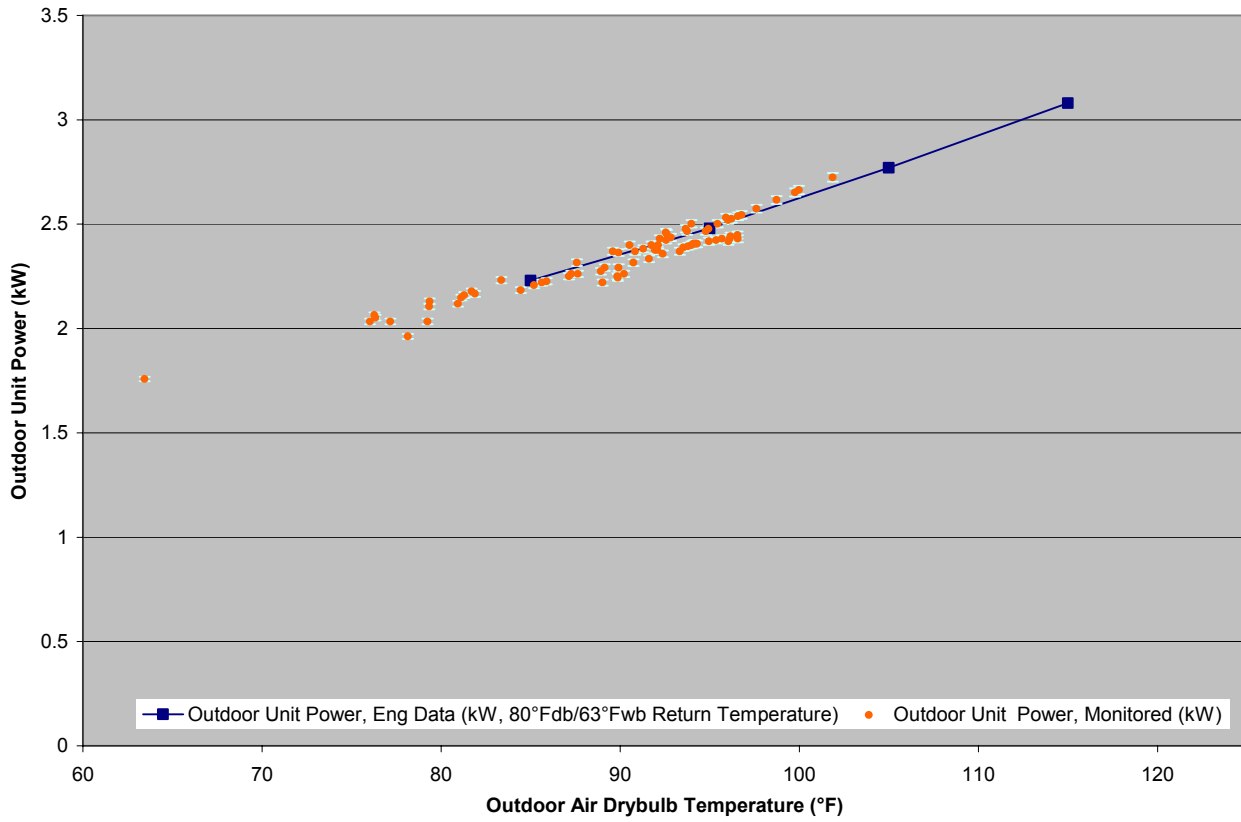
Figure 28 SEER 21 Outdoor Unit Power Comparison, 2nd Stage Operation

Figure 28 shows the comparison of Manufacturer’s power draw data to field monitored data for the SEER 21 air conditioner in 2nd stage cooling at the East Star site.

The comparison to manufacturers power draw is presented for the condensing unit only as including the air handler in the comparison would complicate the comparison unnecessarily due to the difficulty in knowing the duct system static pressure when the system operates (currently there is no measurement of duct system static pressure). Overall in 1st or 2nd stage the field measurements show good agreement to the manufacturer's data.

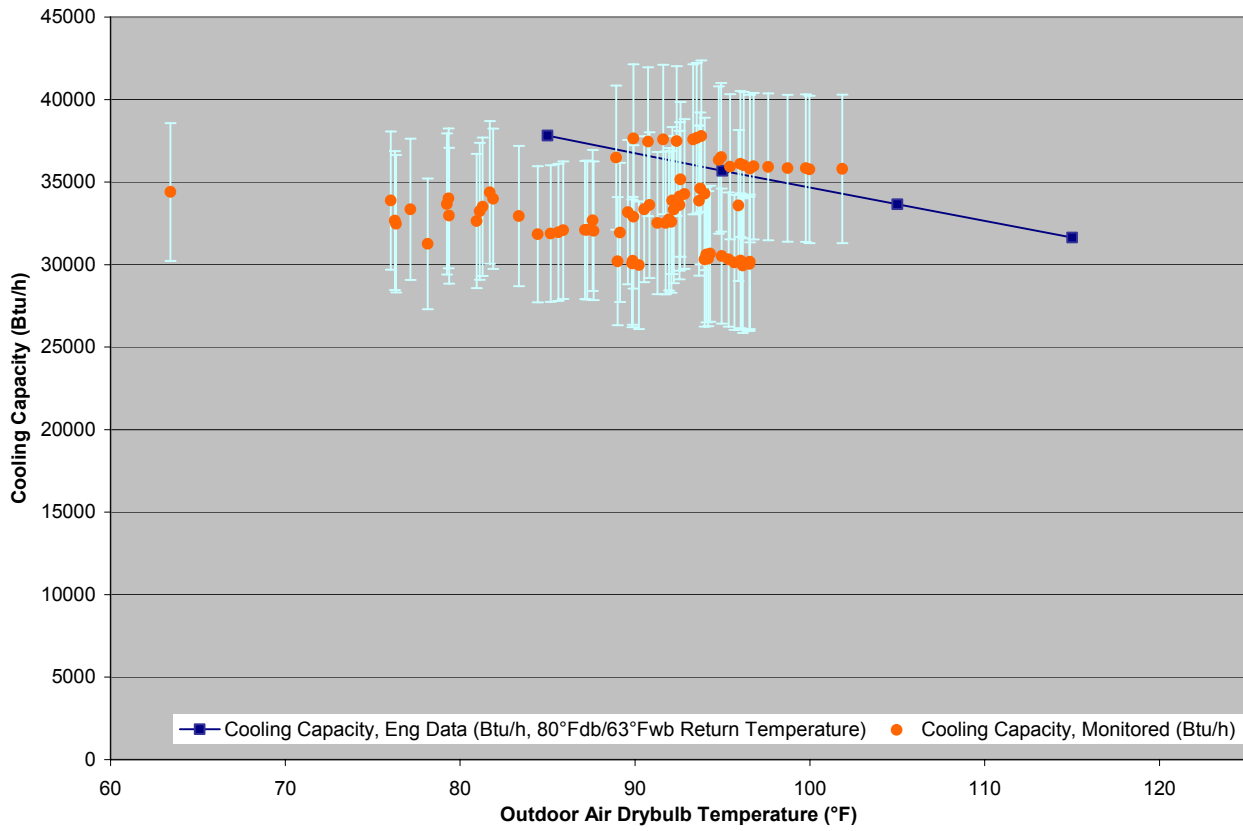
Figure 29 SEER 21 Total Cooling Capacity Comparison, 2nd Stage Operation

Figure 29 shows the comparison of Manufacturer's total cooling capacity data compared to field monitored data for the SEER 21 air conditioner in 2nd stage cooling at the East Star site.

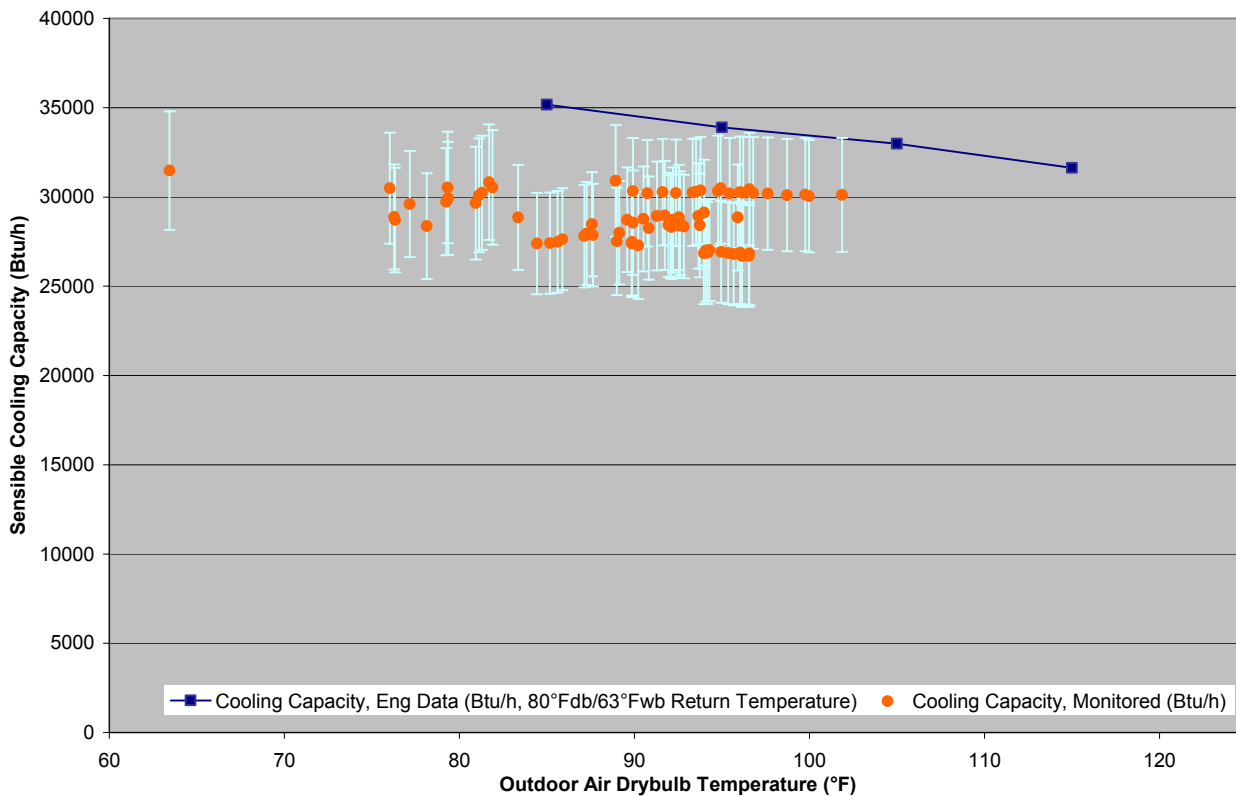
Figure 30 Sensible Cooling Capacity Comparison for SEER 13 Air Conditioner

Figure 30 shows the sensible cooling capacity comparison for the SEER 13 air conditioner.

Data for the SEER 21 air conditioner was only considered from August 2006 until the end of the 2006 cooling season in Borrego due to a relative humidity sensor that appeared to be calibrated incorrectly. As a temporary fix DEG engineers put the air handler fan into “fan only” operation and compared the RH measurement at the supply duct to the RH measurement on the suspect return sensor. DEG engineers modified the datalogger program to include an offset in the RH measurement at the return after collecting several hours of fan only data and accounting for fan heat added to the air stream by the air handler fan. Unfortunately, data from some of the warmer parts of the summer are not available due to the problem with the return RH sensor. This sensor was replaced by NREL staff in a January 2007 site visit in preparation for the 2007 cooling season testing. The comparison shows the measured power for first and second stage operation of the condensing unit appears to agree with the measured data. The measured cooling capacity during 1st and 2nd stage operation is somewhat suspect due to the limitations of the fix that was performed on the return sensor RH measurement. During the May 2007 visit the new return sensor, the old supply sensor and an extra temperature and relative humidity sensor were compared and in consultation with DEG engineers the original supply sensor was replaced so that the original sensor could be evaluated in the NREL HVAC test loop. 2nd stage cooling was disabled for the first half of the 2007 cooling season in order to focus on 1st stage performance.

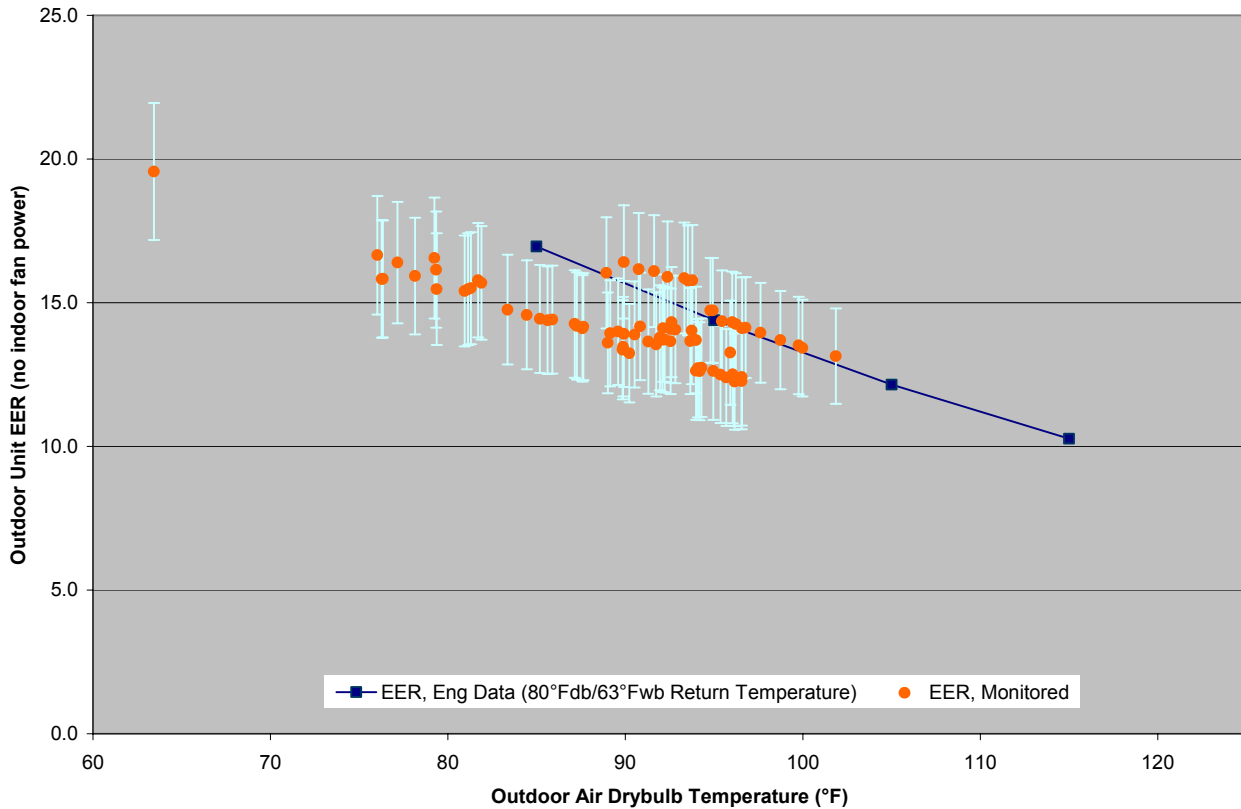
Figure 32 EER Comparison for SEER 21 Air Conditioner, 2nd Stage Operation

Figure 32 shows the EER comparison for the SEER 21 air conditioner in 2nd stage operation.

The measured EER during 1st and 2nd stage operation is somewhat suspect due to the limitations of the fix that was performed on the return sensor RH measurement and the potentially false readings from the supply and return temperature and relative humidity sensors. While the measured EER appears to be in line or exceeding the manufacturer's expectations for 2006, our approach would be to gather additional data during the 2007 cooling season in order to verify the EER of the Lennox unit before arriving at a conclusion as to whether the unit performs according to manufacturer's expectations or not.
