## **BUILDING AMERICA FIELD TEST REPORT**

*NREL / Wonderland Development  
Wonderland Near-Zero Energy Row Houses – Boulder, CO*

***Paul Norton, Lee Magnusson, and Bob Hendron, NREL  
Ed Hancock and Greg Barker, Mountain Energy Partnership***

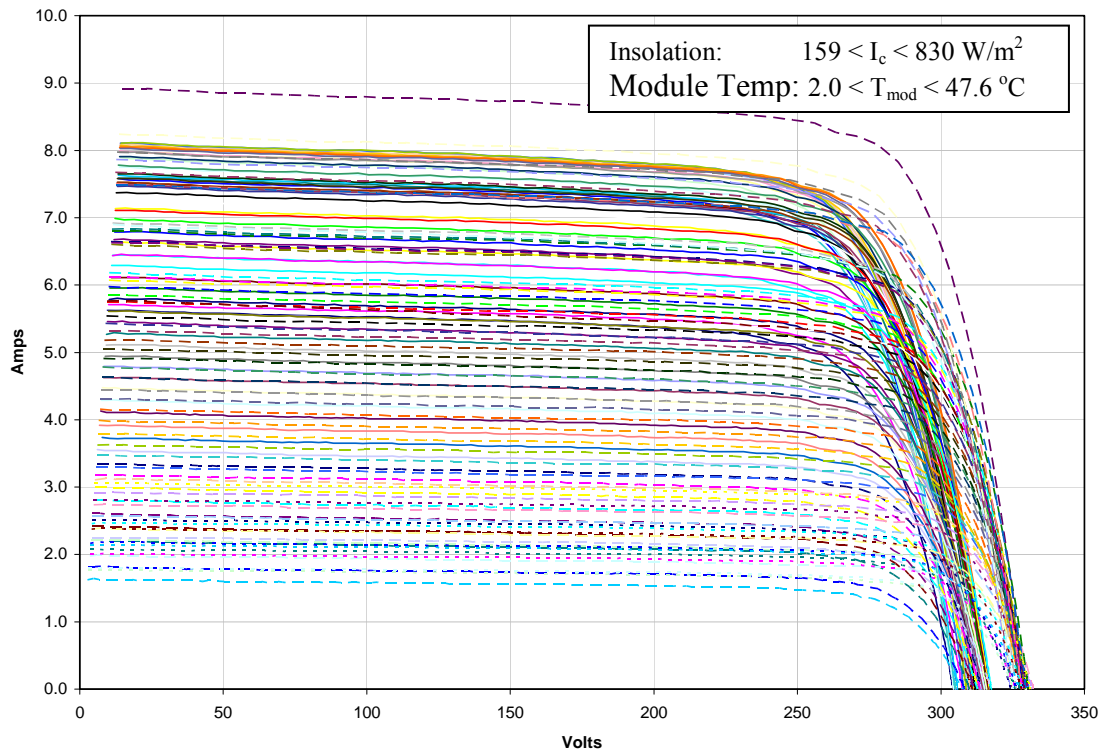
**Figure 3: Set of Current-Voltage curves measured between Nov. 19, 9:25 AM and Nov. 20, 11:45 AM.**

have been changing quite slowly and the curves should have been smooth. A typical cause of these types of anomalous curve shapes is a mismatched array (one or more modules not operating at the same efficiency as the others). This anomaly is small and is not expected to affect overall performance appreciably. In the past, we have found that anomalies such as this can be caused by objects shading a small portion of one module of the array. It is also possible that there was a problem with the curve-tracing equipment itself. We expect to return to the site this coming summer to repeat the curve trace and investigate the anomaly further.

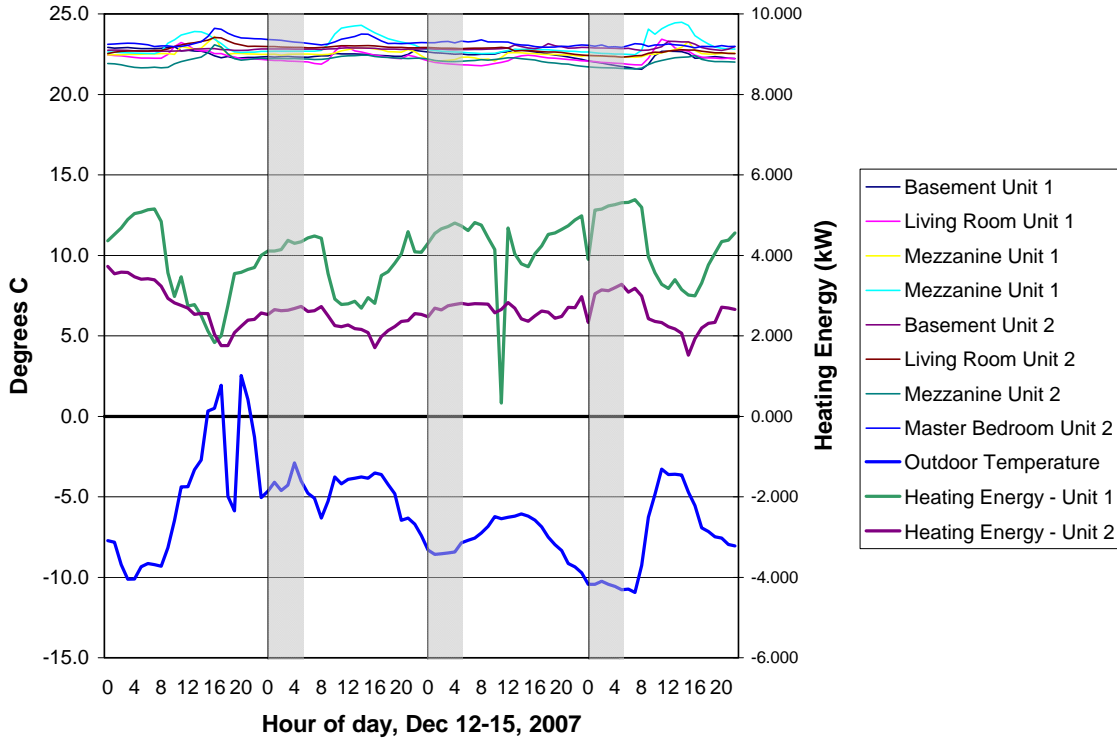
**Figure 8: Temperatures and electricity use during coheating testing, Dec 12-15, 2007**

controlled electrical resistance heaters were deployed throughout both homes to maintain uniform temperatures. With this configuration, the heating load can be measured by monitoring the total electricity into the home. The space temperatures on each floor of both units, the outdoor temperature, and the total electricity used in both units during the coheating test are shown in Figure 8.

As shown in Figure 8, the space temperatures on all floors of both units were within a few degrees for the entire test. The daytime temperatures in both units were elevated somewhat by solar gains on Dec 12, 13, and 15. To compare the heating loads of the two units independent of solar gains, we analyzed the heating energy during the nighttime from midnight to 5 am on Dec 13-15 (indicated by the shaded regions in Figure 8). The results, shown in Table 5, are presented as the heating load per degree of indoor/outdoor temperature difference.

With no sunlight, unit 2 requires about 20% less energy to heat per unit of floor area than unit 1 due to the fact that it is an interior unit. As illustrated in Figure 8, this difference is narrowed or eliminated during daylight hours by the greater solar gain in unit 1. For example, in the early afternoon of December 12, the total heating requirements of unit 1 were nearly identical to unit 2 due to the greater solar gain in unit 1. Therefore the heating requirements in unit 1 per square foot of conditioned space were less than those of unit 2 during this period.

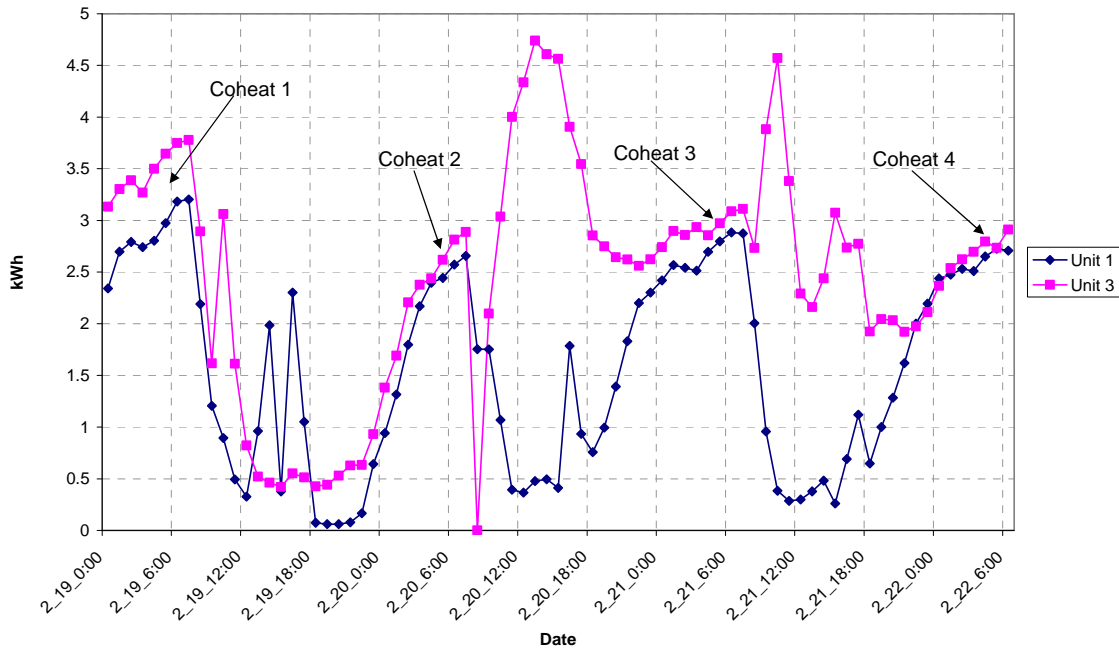
**Figure 9: Coheating results for Unit 3 and the adjacent unit.**

It would be of interest to compare the daytime electric power use of the two units as well, however, there were significant disturbances from workers in the units (especially Unit 3) during the day so the comparison is not useful.

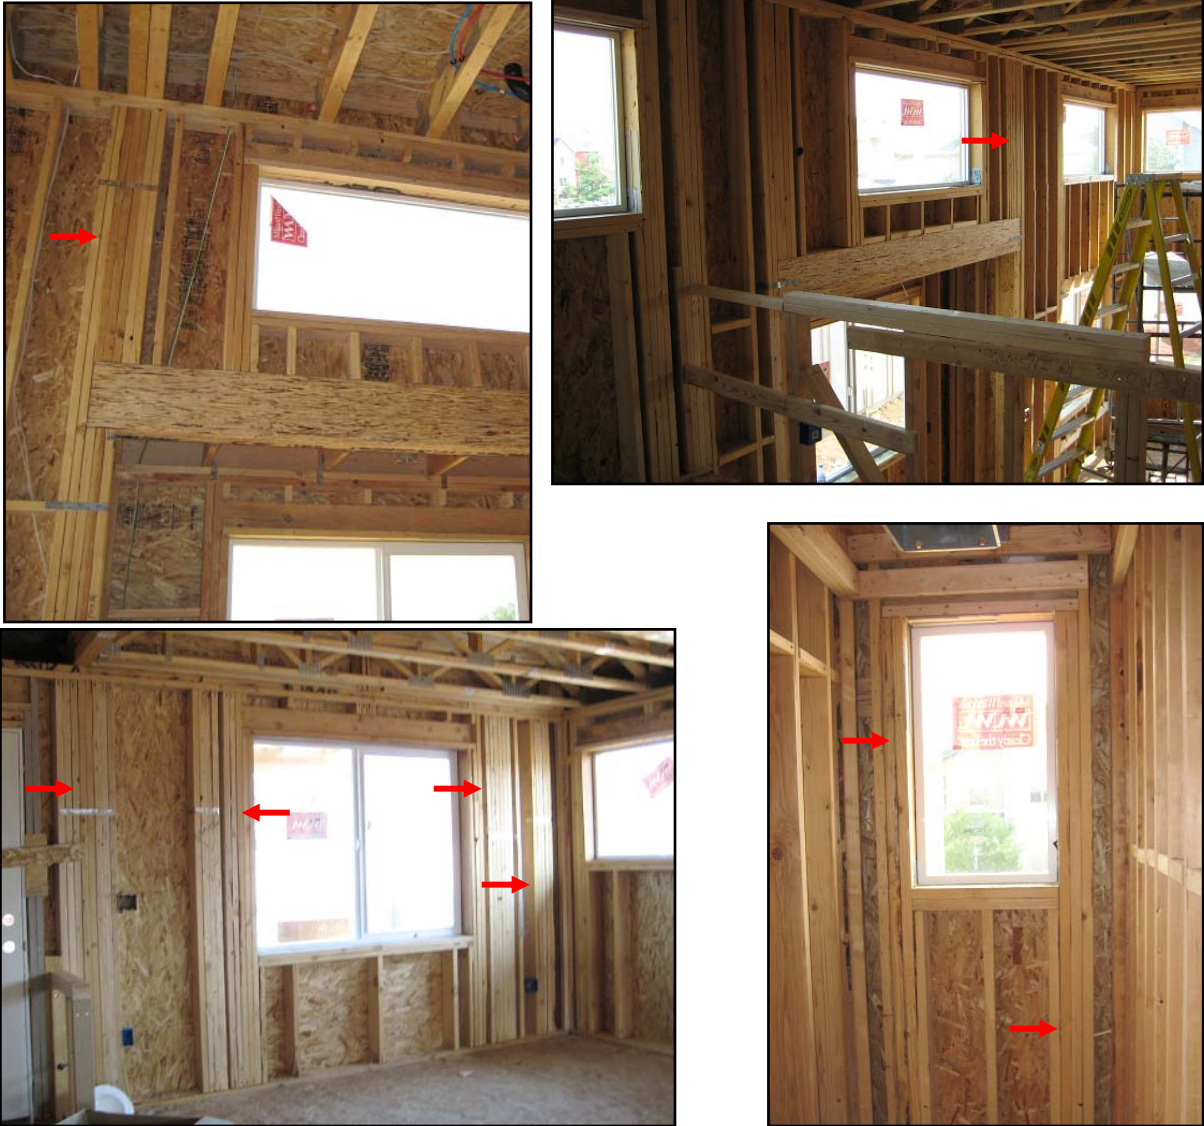
**Figure 10: Examples of side-by-side stud bundles**

However, there are areas in the homes with many studs side-by-side that create potentially significant thermal bypasses and lower the overall insulation level of the homes. Some examples are shown in Figure 10. These bundles of studs can be clearly seen in the thermal imaging of the finished homes. Examples are given in Figures 11 and 12.

Many, if not all of these side-by-side stud columns may be needed to render structural integrity to the design. Therefore designs intended to achieve very high overall thermal performance should attempt to minimize these types of thermal bypasses. Architecturally interesting designs with simpler wall geometry may be able to achieve similar quality of spaces with less need for distributed side-by-side stud columns and therefore be able to achieve a higher effective R-value with the same nominal R-value insulation.

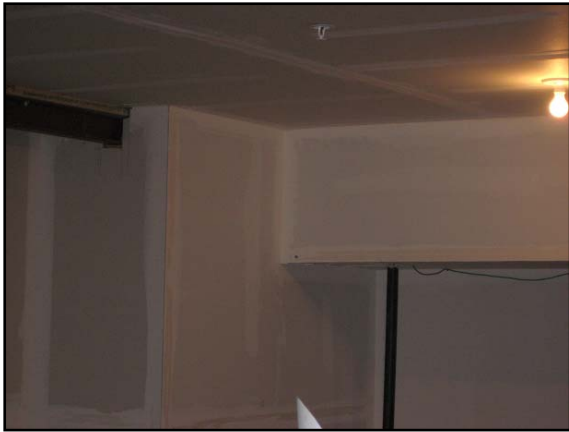
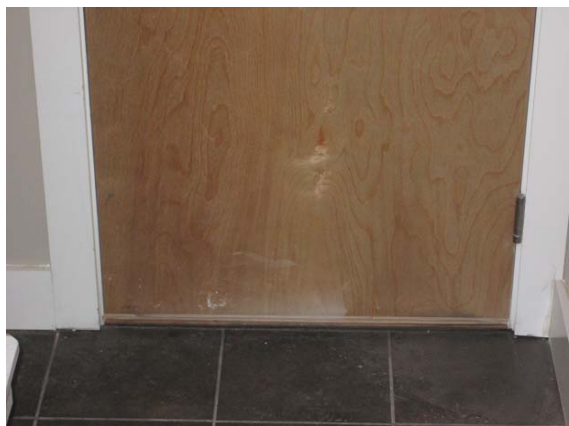
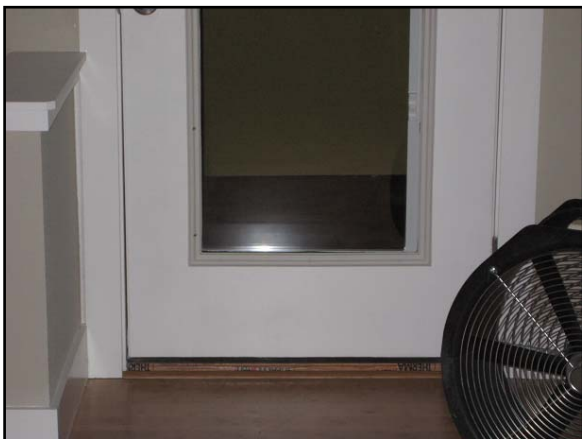
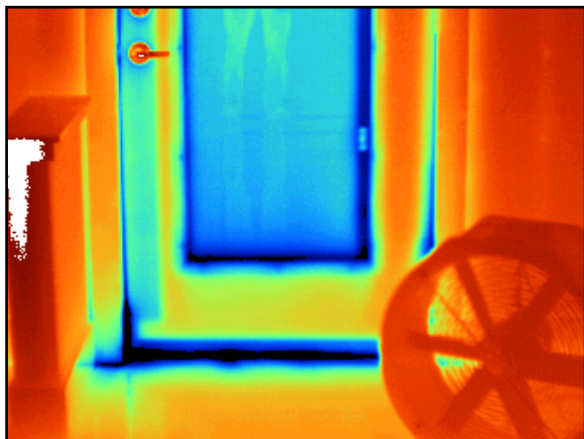
**Figure 13: Thermal images of air infiltration in unit 1**

During blower door testing we noticed air leakage under exterior doors and in some other areas in both homes. The effects of these leaks can also be seen in the thermal imaging shown in Figures 13 and 14.

Unit 1 – SW corner of basement

Unit 1 – Door to garage

Unit 1 – Door to deck

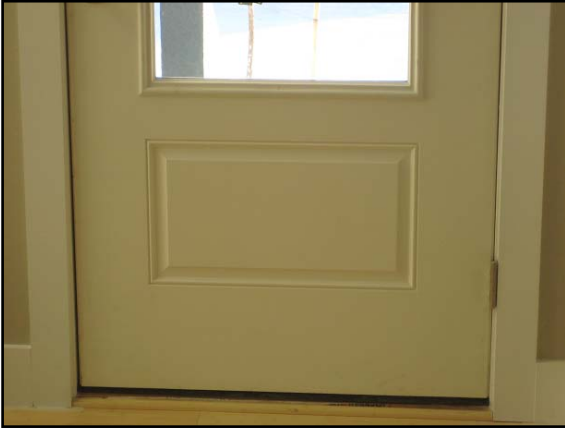
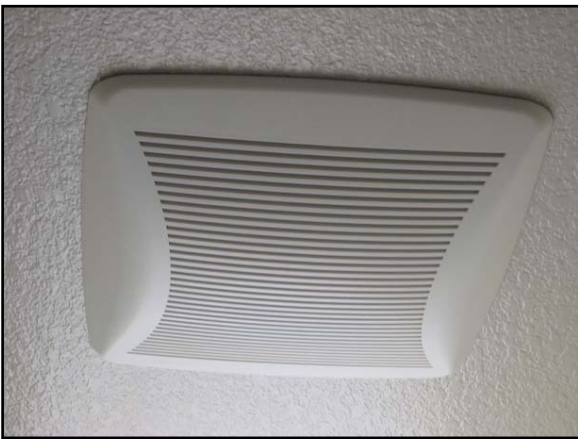
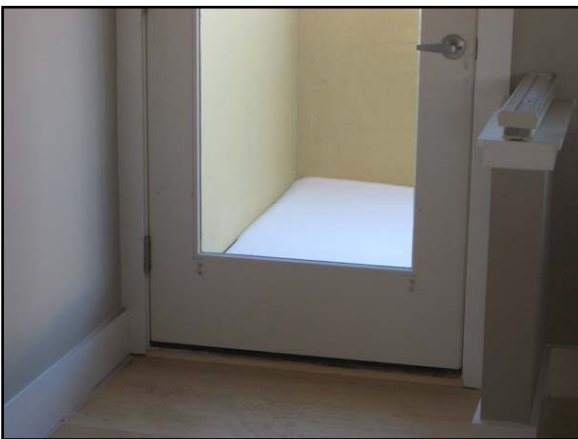
**Figure 14: Thermal images of air infiltration in unit 2**

Unit 2 - Front door

Unit 2 - 1<sup>st</sup> floor ½ bath exhaust fan

Unit 2 – Door to deck

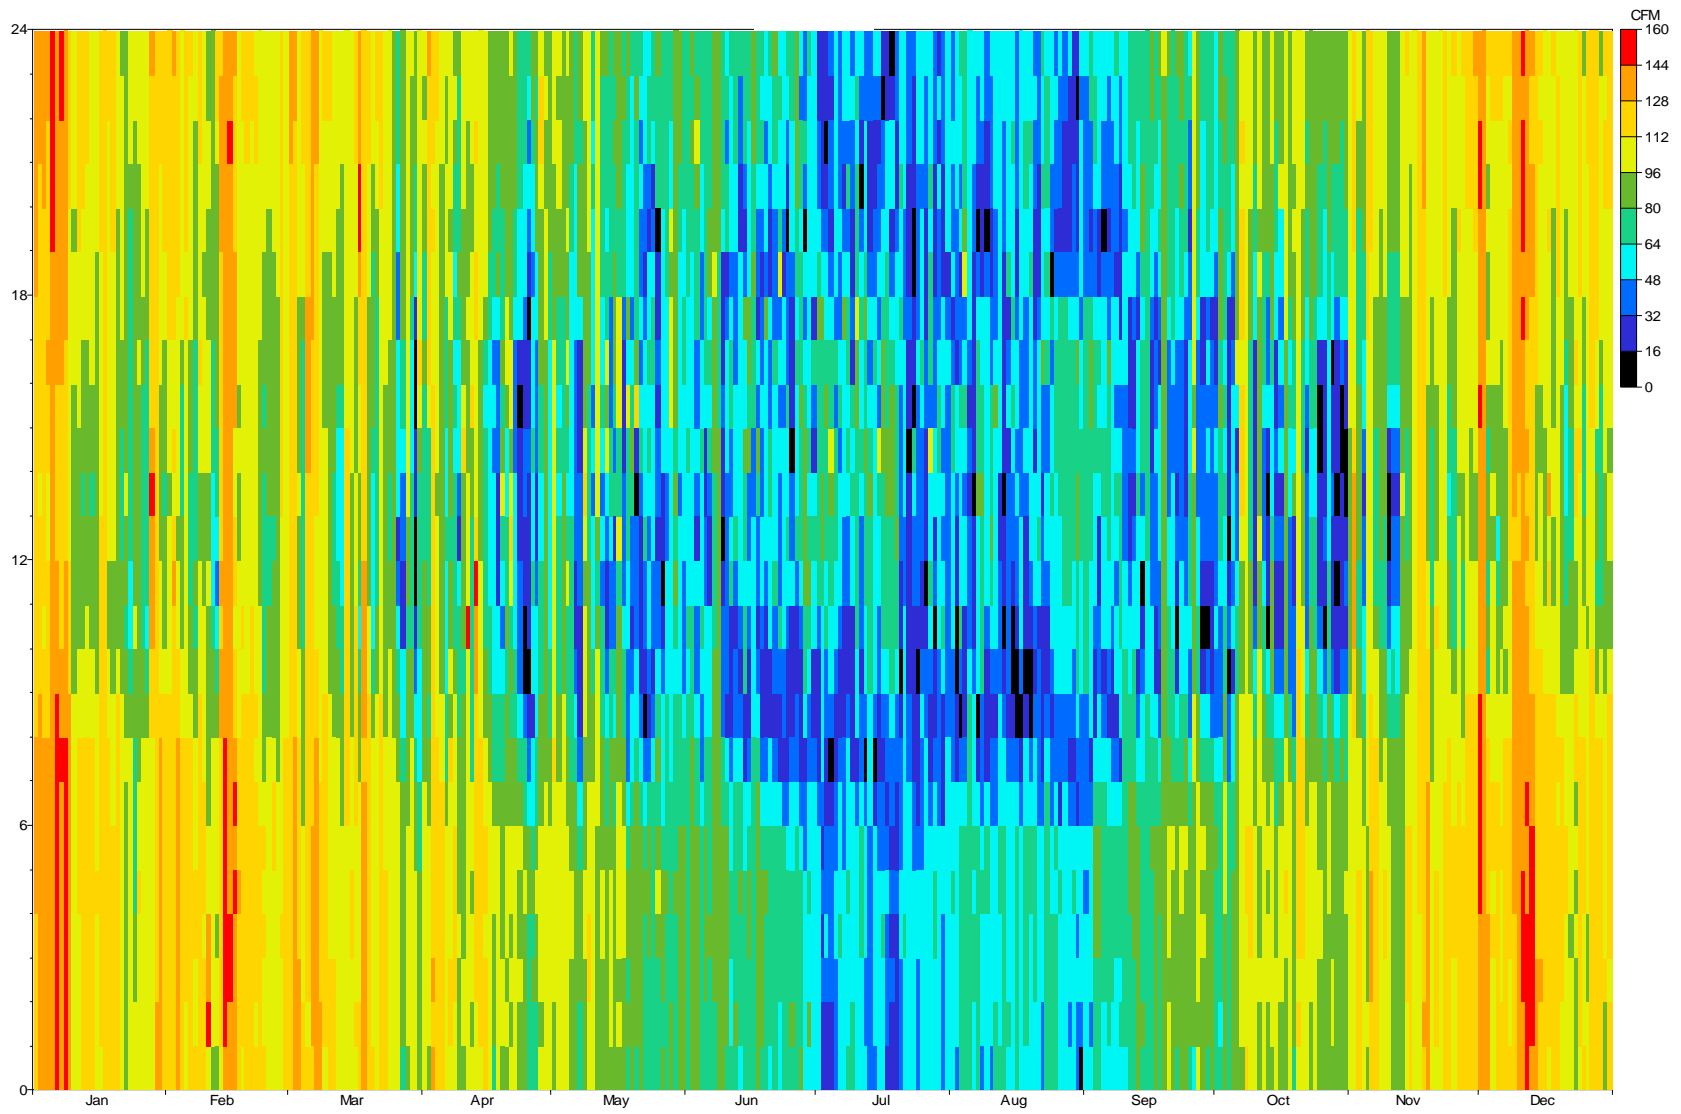
**Figure 16: Typical hourly natural infiltration for unit 1**

applied the Lawrence Berkeley Laboratory infiltration model presented in the ASHRAE Handbook of Fundamentals. The results are shown in Figures 16 and 17. These figures show the predicted typical hourly infiltration rate for an entire year. The color of each slice represents the natural infiltration rate during that hour. Along the x-axis is each day of the year. The hour of the day is represented on the y-axis.

The natural infiltration never exceeds 152 cfm in unit 1 and exceeds 114 cfm in unit 2 for only 1 hour of the year. However, the ASHRAE 62.2 default infiltration rate is exceeded 85% to 87% of the year in both units.

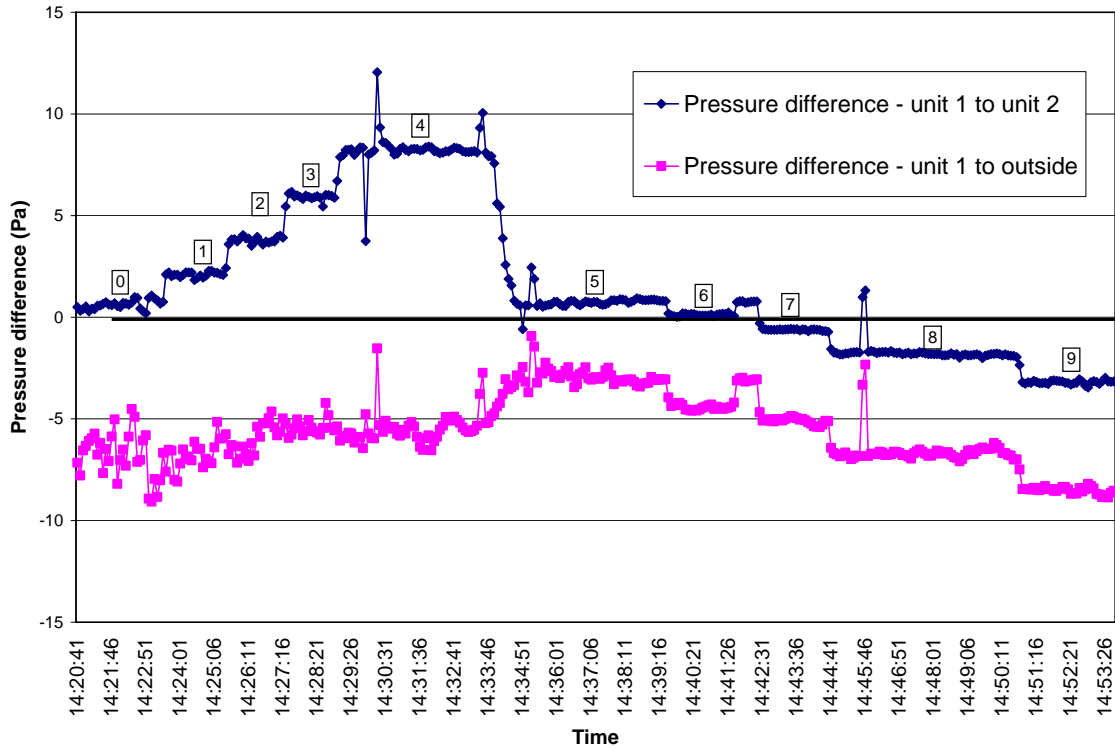
**Figure 18: Pressure differences between units 1 and 2 and from unit 1 to the outside**

Continuing our investigation of the leakage through the party wall we measured the pressure differences between units 1 and 2 and between unit 1 and the outside while operating exhaust fans in both units. The pressures were measured in the living room of both units. The results of this investigation are shown in Figure 18. Most of the sharp spikes in the figure are exterior door openings in the units. In points 1-4 of the figure exhaust fans are operated in unit 2. In points 6-9 exhaust fans are operated in unit 1. Note that the pressure difference between unit 1 and the outside is about 7 Pa. This represents the driving force for natural infiltration on the kitchen/living room level. As fans in unit 2 are switched on the pressure difference between the units increases. When 3 of the fans are turned on the pressure difference between the units is about the same magnitude as the pressure difference between unit 1 and the outside. Each unit has 3 bathroom exhaust fans, laundry closet exhaust fan, a stove exhaust fan and a clothes dryer. Depending on how these are operated in adjacent units it is reasonable to expect that the infiltration driving force between the units may be equal to or greater than the infiltration driving force to the outside. It is reasonable to expect a significant air exchange between units under these conditions.

Explanation of points on the graph	
0	No exhaust fans in either unit are operating
1	Unit 2: east bath fan on
2	Unit 2: east bath and laundry room fans on
3	Unit 2: east bath, laundry room, and west bath fans on
4	Unit 2: east bath, laundry room, west bath, and powder room fans on
5	No exhaust fans in either unit are operating
6	Unit 1: powder room fan on with fan grill taped off
7	Unit 1: powder room fan on tape removed
8	Unit 1: powder room, master bath fans on
9	Unit 1: powder room, master bath, 2 <sup>nd</sup> bath fans on

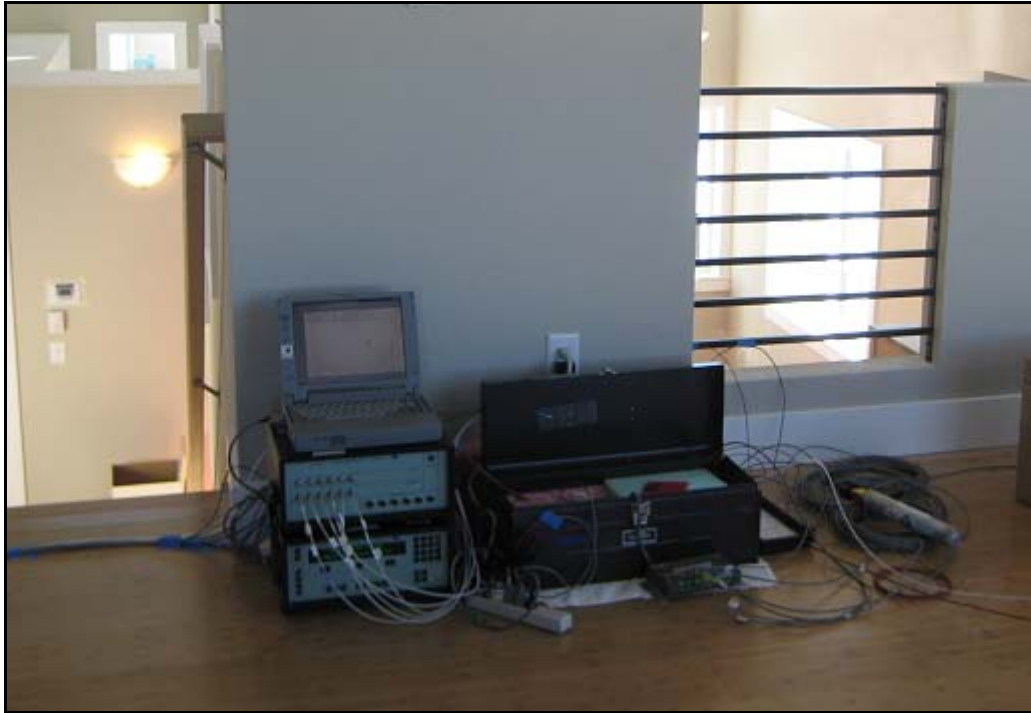
**Figure 19: Photo of tracer gas set-up in unit 1.**

B&K model 1303 multi point sampler is used to draw an air sample from up to six points around the house for analysis with the 1302 analyzer. Figure 19 shows a photograph of the tracer gas system installed in unit 1. In unit 1, there are six sample points including the basement, living room, second floor, master bedroom, northwest bedroom, and southwest bedroom. Unit 2 has similar sample locations, except that there are only two bedrooms. For these tests, the time interval between samples was 2 minutes, with a complete cycle through the 6 sample points taking 12 minutes. An entire tracer decay test for these houses lasted between 6 and 12 hours, depending on the actual air exchange rate.

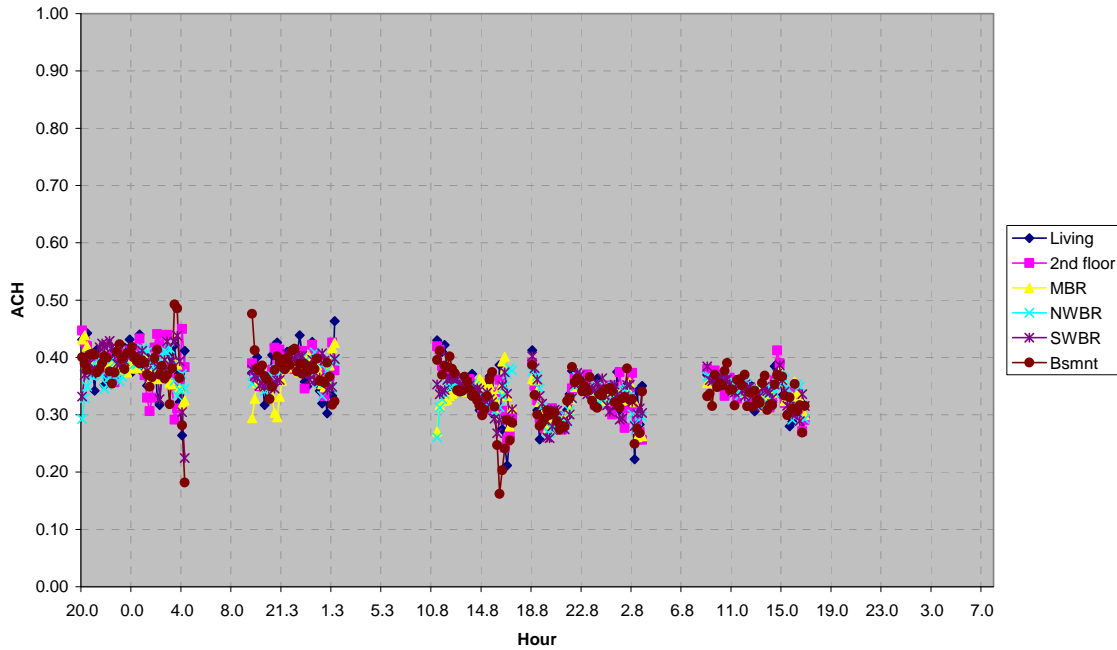
Figure 20: Air exchange rate measurements for Unit 1.

The time series data for the measured ACH in Unit 1 is displayed in Figure 20. The multiple sample points show insignificant variation from room to room, implying that good mixing was achieved. During each test period, there was generally not much change in the measured ACH over time, indicating relatively stable weather conditions. The operating conditions for all of these tests were the same with all interior doors open, mixing fans operating continuously, exhaust fans off and inside temperature controlled using electric heaters.

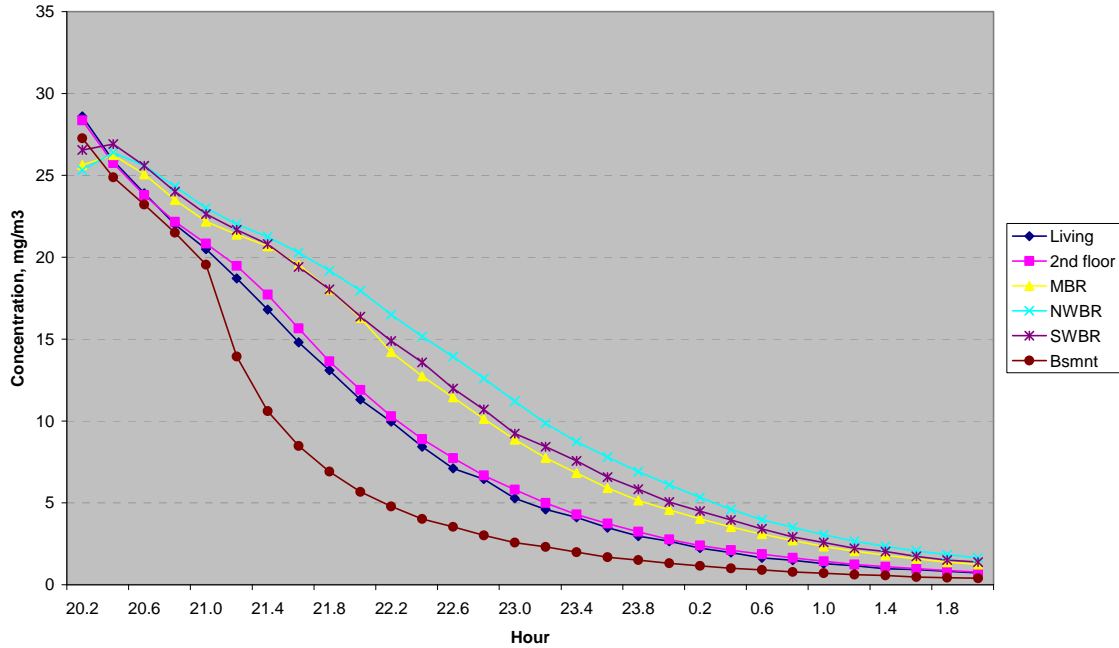
**Figure 22. Unit 1, decay 6 showing the room to room variation on concentration.**

The tracer gas decay number six in Unit 1 shown in Figure 22 is an example of the multi-zone variation in concentration. The concentration in the basement zone decays much faster than the concentration on the top floor bedrooms, indicating that fresh air enters at the lowest level and exits at the top. This test was not analyzed to determine reciprocal age of air because adequate initial mixing could not be achieved.
